**MARYLAND HISTORICAL TRUST
DETERMINATION OF ELIGIBILITY FORM**

Property Name: Springfield Dairy Farm Inventory Number: F-3-76
Address: 12108 Auburn Road City: Lewistown Zip Code: 21701
County: Frederick USGS Topographic Map: Catoctin Furnace
Owner: Evelyn and Arne Wasli Is the property being evaluated a district? ☐ yes
Tax Parcel Number: 22 Tax Map Number: 32 Tax Account ID Number: 20-399759
Project: Cingular Cell Tower, Catoctin #2005 Agency: Federal Communications Commission
Site visit by MHT Staff: ☒ no ☐ yes Name: _____ Date: _____
Is the property located within a historic district? ☐ yes ☒ no

Building Description and Significance

The Springfield Dairy Farm is an agricultural complex centered on a circa 1820 log house with several periods of additions and interior alterations, with a two-level stone springhouse of about the 1830's and an attached frame summer kitchen of about 1900. The agricultural group includes two barns, one a circa 1941 replacement for the original bank barn. A hog barn, a frame wagon shed with corn cribs, a garage, and a machine shop, and a large chicken house complete the group. The most important architecturally are the stone springhouse, in which th

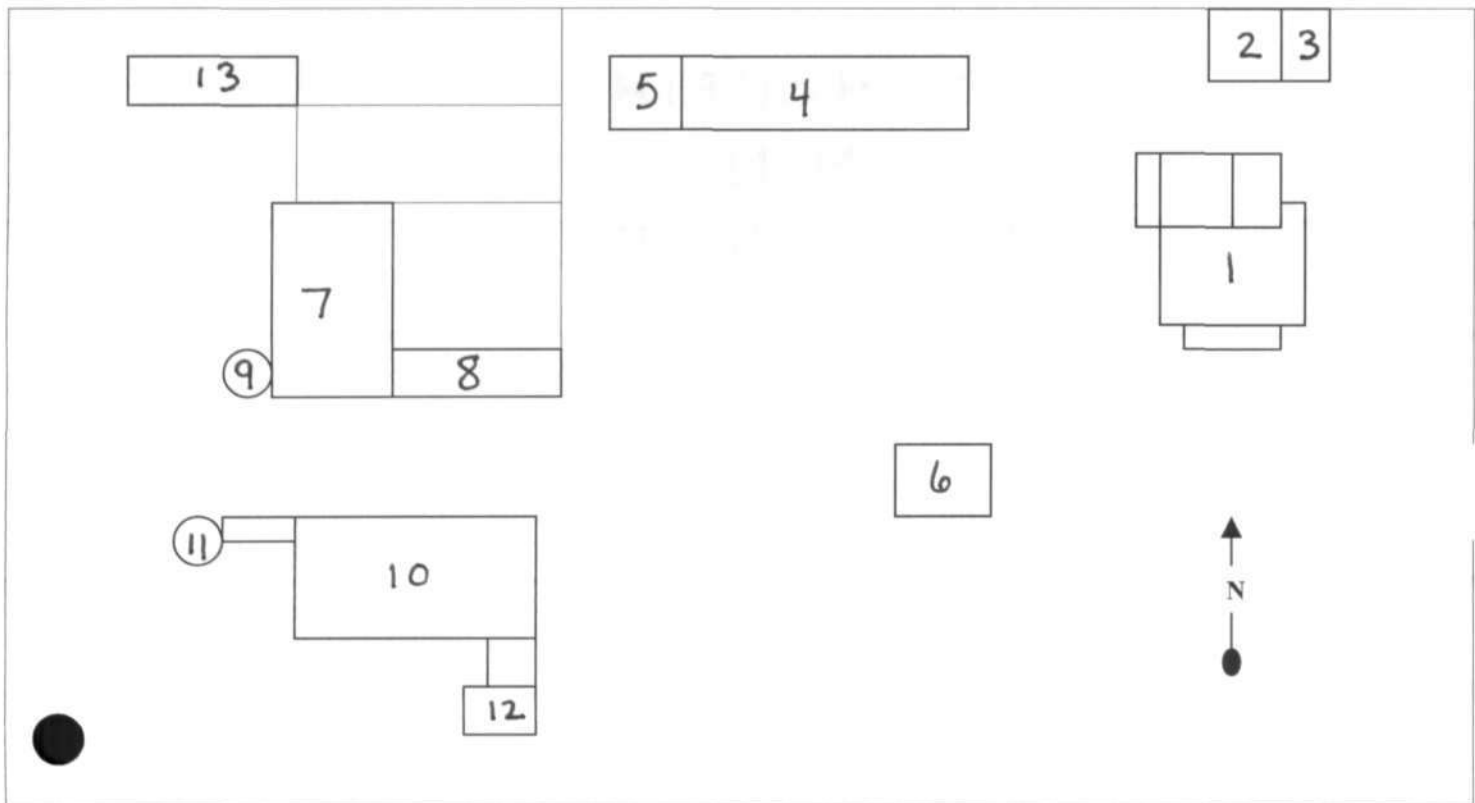
Springfield Dairy Farm Site Plan

The building arrangement on most of the region's farms corresponds to a recognized pattern. Springfield Dairy Farm's buildings are paced in manner known as a range plan. In this configuration the house stands adjacent the main road while the farm lane runs along the side of the house. Farm buildings are located behind the house, facing the lane, with those related to domestic function placed closest to the dwelling and the barn(s) farthest from it.¹⁰ Springfield dairy farm is a good example of this classic farm plan.

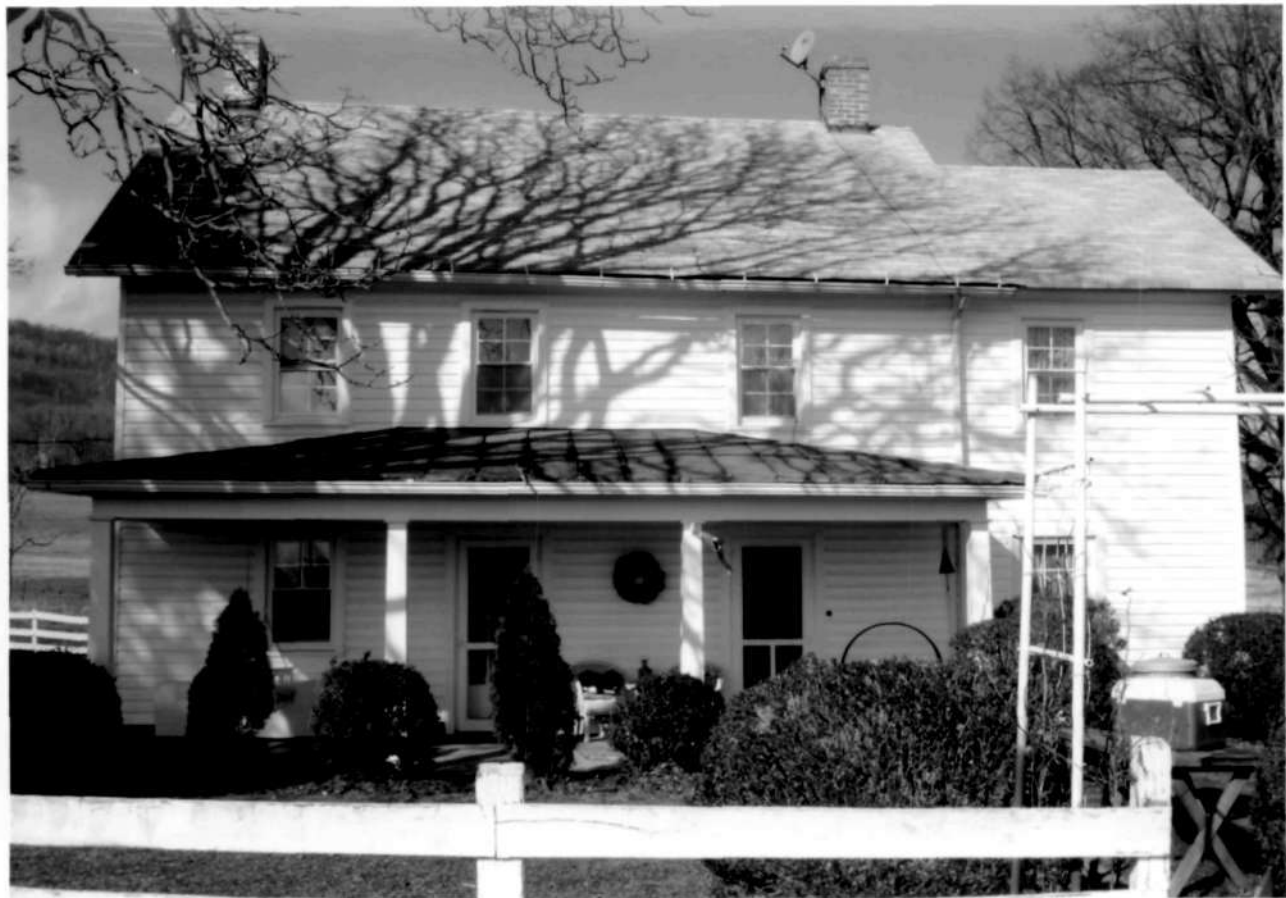
photo 1 of 21

The Springfield Dairy farm consists of a two-story, double-pile-plan, **house (1)** with large rear ell and telescoping addition. The low-pitch, gable roof is covered with asphalt shingles. The house is badly altered with little in the way of original interior finish but is interesting due to the fact that part of the building features log construction. The extent of the log construction is not clear, either from the original survey form or the very limited examination of the house allowed by the current owners. The owners report that only the front (south) wall of the main house is log but, unless the logs were fitted into corner posts rather than traditional notching, this seems unlikely. The house also features two front doors and as a result resembles the region's many German-influenced farmhouses.

Here the double front door configuration is not an ethnic-influenced vernacular expression, but according to the owners, was created relatively recently when the dwelling was converted into a duplex. The 1992 survey form indicates that the oldest part of the house was built about 1820. The survey form's author ascribes this date based architectural evidence, but does not specify the nature of the evidence. The very cursory examination of the house allowed in conjunction with this DOE was not useful in either validating or disproving an 1820s construction date. A \$1,500 increase in sale price between January 1841 and June 1844 could indicate significant physical improvements taking place during that time and represent the construction of the house, but may simply reflect the presence of a planted crop. The date of construction, therefore, remains uncertain.

Front Facade of Dwelling

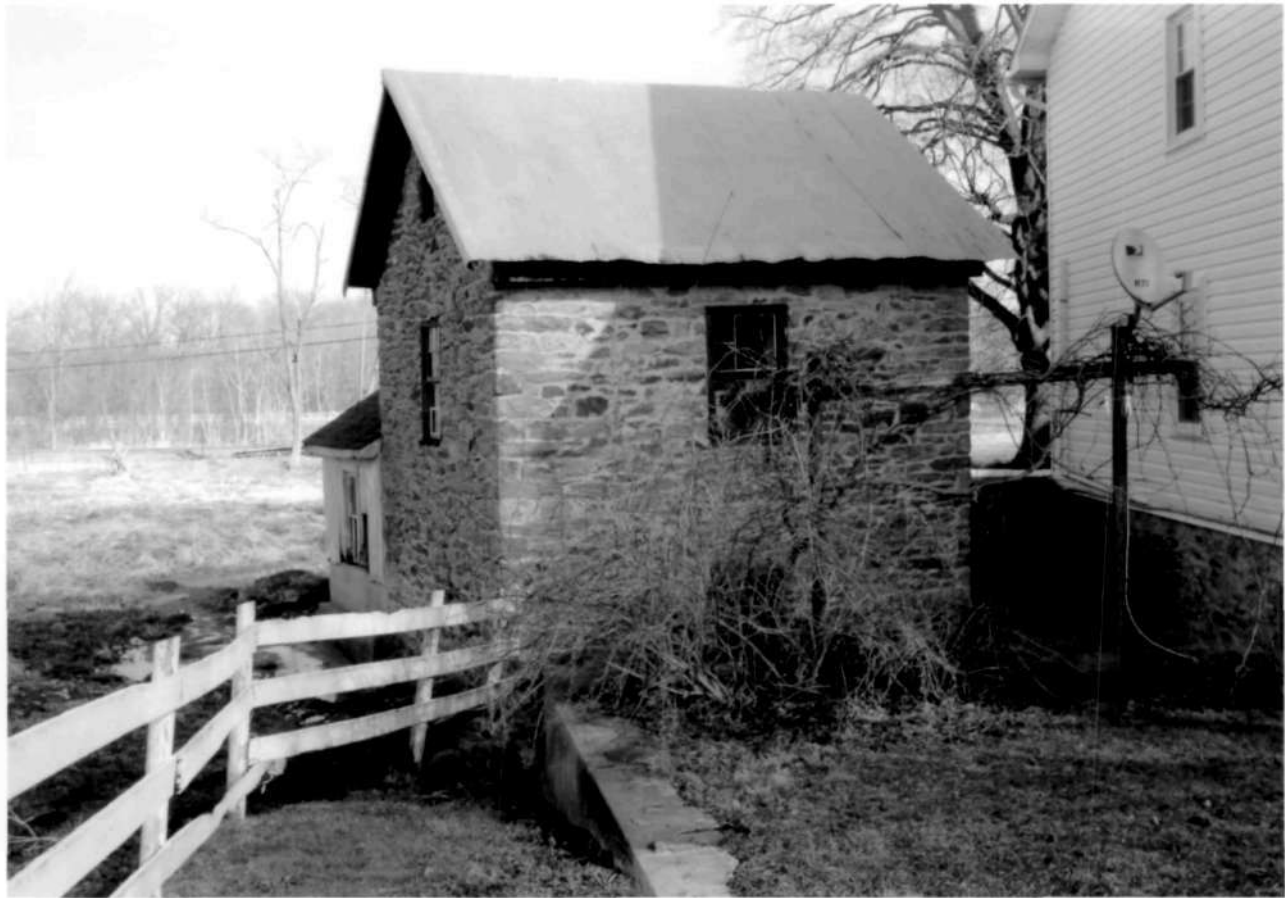
photo 5 of 21

The farm's most interesting building is located immediately behind (north) of the main house. The two-and-a-half-story, stone **springhouse (2)** measures approximately 12' x 12' and has metal-covered gable roof. The lower level is situated below grade and, in an unusual treatment, is connected to the rear of the dwelling by a wooden bridge/ramp. The building is in very good condition and retains a high degree of physical and historic integrity. The building's lower level was used to keep dairy products and other perishables cool, while the upper level provided storage space. The associated spring remains active. The gable roof's eaves project on the front and rear but are nearly flush at the sides. Three, six-over-six, double-hung, wood-sash windows and a fixed-sash attic light illuminate the upper storage level. Both levels feature a board-and-brace door. The wooden door and window jambs feature mortise and tenon construction. The 1997 survey form ascribes an 1830s construction date to the springhouse and nothing was observed in this investigation that counters that assertion. Springhouses were common on the nineteenth-century Maryland Piedmont and Blue Ridge landscape where dairy production constituted a major element of the domestic economy, but due to their obsolescence and development pressures, these buildings are becoming increasingly rare. Two-story examples such as this were common in the trans-Appalachian South and parts of Pennsylvania.²

Springhouse

Springhouse: The two-story stone springhouse has vertical board doors on the south elevation on each level. In the west elevation is a 6/6 window and a beaded board door. The stone walls have been recently repointed. The roof is covered with corrugated metal. On the east elevation is a one-story frame summer kitchen with an exterior stone and brick chimney. The kitchen is covered with vertical siding and the foundation is concrete block. The roof is wood shingles. The south elevation has a vertical board door and a 2/2 window. The springhouse was probably built shortly after the house in the 1820's or early 1830's, based on its rubble stone structure. The summer kitchen may have been added in the early 20th century, as indicated by the concrete block foundation, although the chimney appears to be older.

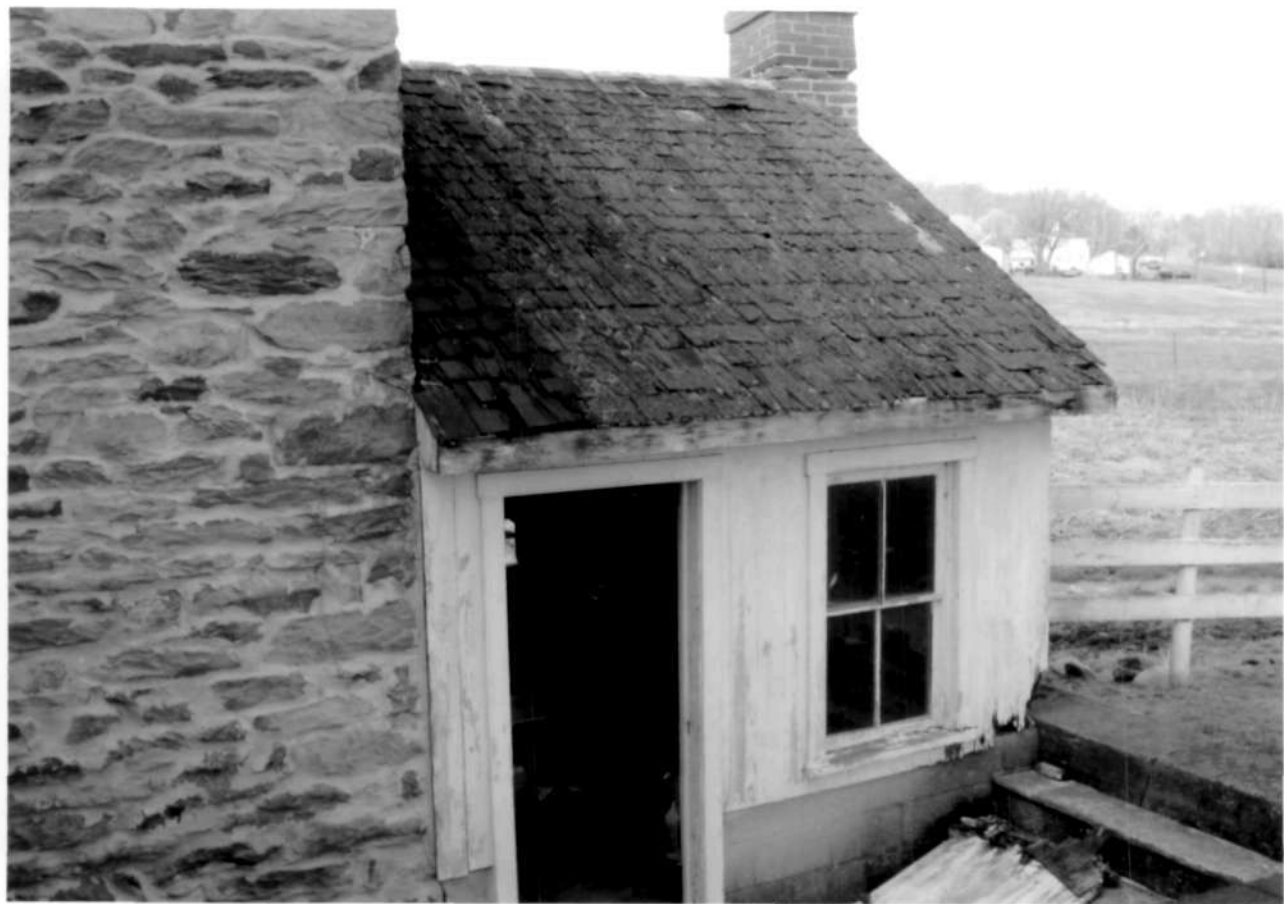
Photo 6 of 21

A frame **kitchen (3)** building extends from the east wall of the springhouse. It is in fair condition and, except for the concrete block foundation, retains all of its historic fabric. The stone firebox appears older than the present kitchen and relates to an earlier structure. The kitchen's construction methods, as well as window placement in the springhouse, indicate the original kitchen post-dated the springhouse. The fact that the masonry is less expertly executed and the mortar different than that of the seen on the springhouse further suggest two periods of construction. The current kitchen dates to the 20th century. The 2/2 sash window appears to be recycled; perhaps from the house. The kitchen's brick chimney stack significantly post-dates the firebox and possibly the kitchen was well. The building's interior is unfinished.

Farm and plantation owners commonly constructed a separate building in which to carry out cooking, washing and other hot and unpleasant smelling chores. The kitchen's firebox probably dates to the first half of the 19th century, as examples from the second half of the 19th century generally featured a cook stoves instead of a fireplace. The popularity of kitchen buildings waned at different times in different regions. According to Lanier and Herman, the tradition of a separate kitchen building began to fade in the Philadelphia backcountry as early as the 1760s, but in the Chesapeake Bay region separate buildings endured into the early 20th century.³

F-3-76
Springfield 12.1.1. From
Frederick Co
Ex Cherry Wood St
January 2006
Neg. at MD SHPO
Kitchen Detail

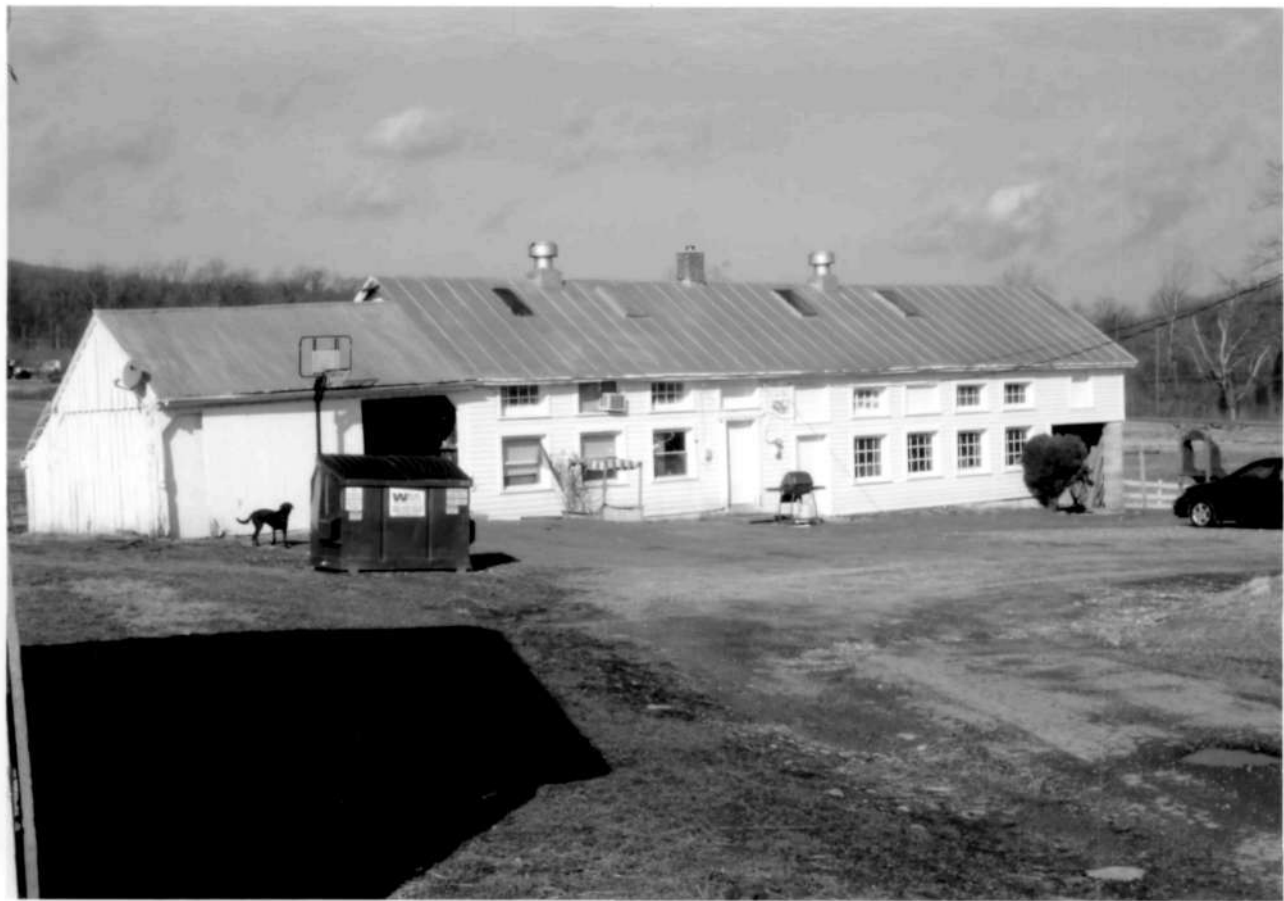
Photo 6

Springfield Dairy farm's agricultural buildings include a large **chicken house (4)**. This c. 1930s, 1-½ story frame structure is located west of the house and is constructed perpendicular to an earthen bank. It measures approximately 75' in length. It is in good condition and the exterior retains a fair degree of historic integrity. The gable roof is sheathed with standing-seam metal and pierced near the ridge by two ventilators and a centrally placed brick chimney. Walls are sheathed with German siding. Originally seven, 12-light, fixed-sash windows punctuated the lower level of the front façade, while nine, 8-light openings illuminated the upper level. Several openings are enclosed or refitted with modern windows. Two pedestrian entrances are centered on the façade but the original doors are removed. The interior of the west half was completely changed when this section was converted into an apartment in the mid-20th century. The eastern section provides storage space and is mostly intact.

A frame **wagon shed (5)** extends from the west side of the chicken house. The building's appearance, as well as the color and texture of the shed's poured foundation, suggests it was constructed at roughly the same time as the chicken house. This common building type first appeared with the rise of mechanized farming. It was, and is, used to protect farm equipment. This example is in good condition and retains its integrity.

Chicken House And CART SHED

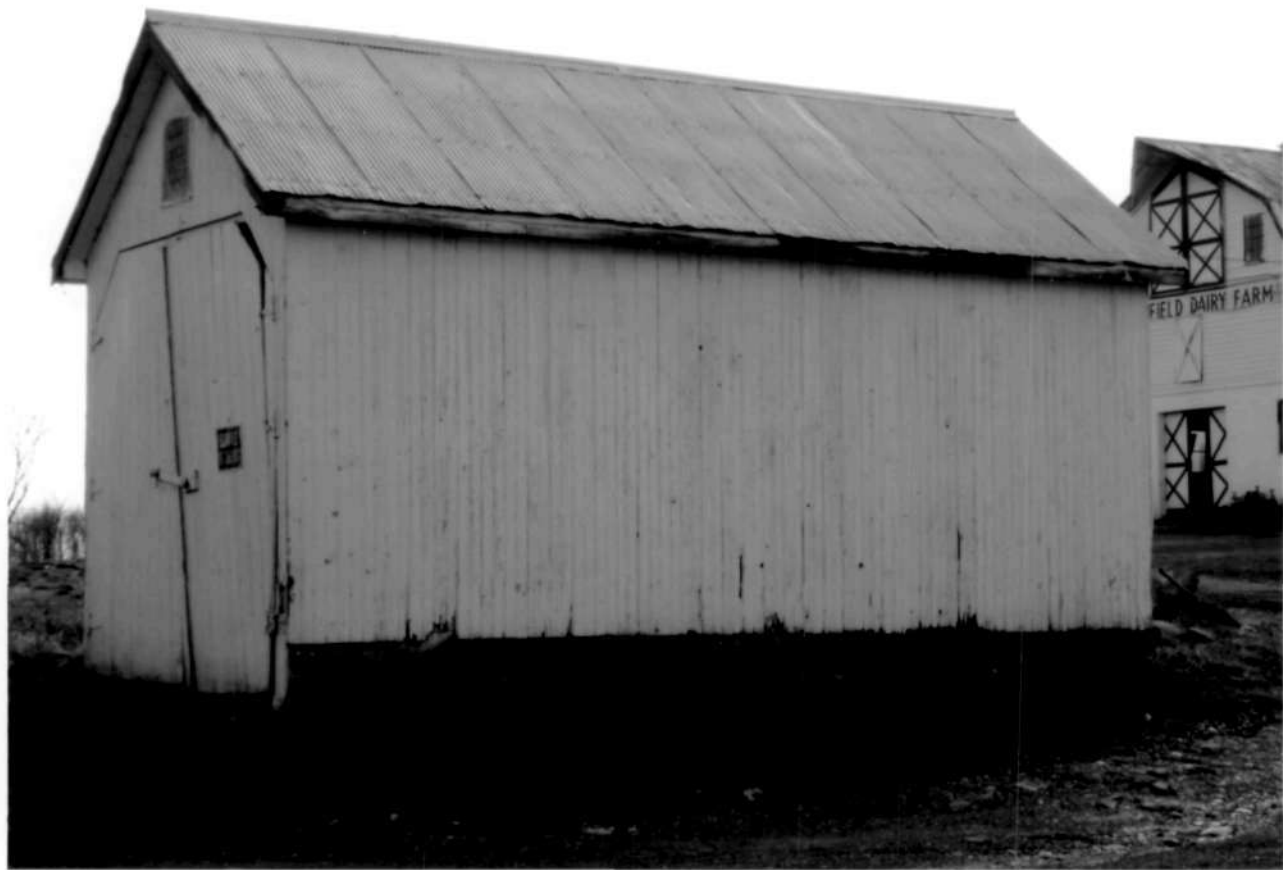
A small, frame, mid-20th-century **garage (6)** is located west of the house and adjacent the driveway that leads to Auburn Road. It is a frame building with gable roof sheathed with corrugated metal, and walls clad with narrow-gauge vertical siding. The double doors are located in the east gable end. It is in fair condition.

GARAGE

Garage: The frame garage is a small building located south of the chicken house. Built about 1940, it has a poured concrete foundation, tongue-and-groove siding, and a corrugated metal roof. Double vertical board swing doors are located in the east elevation.

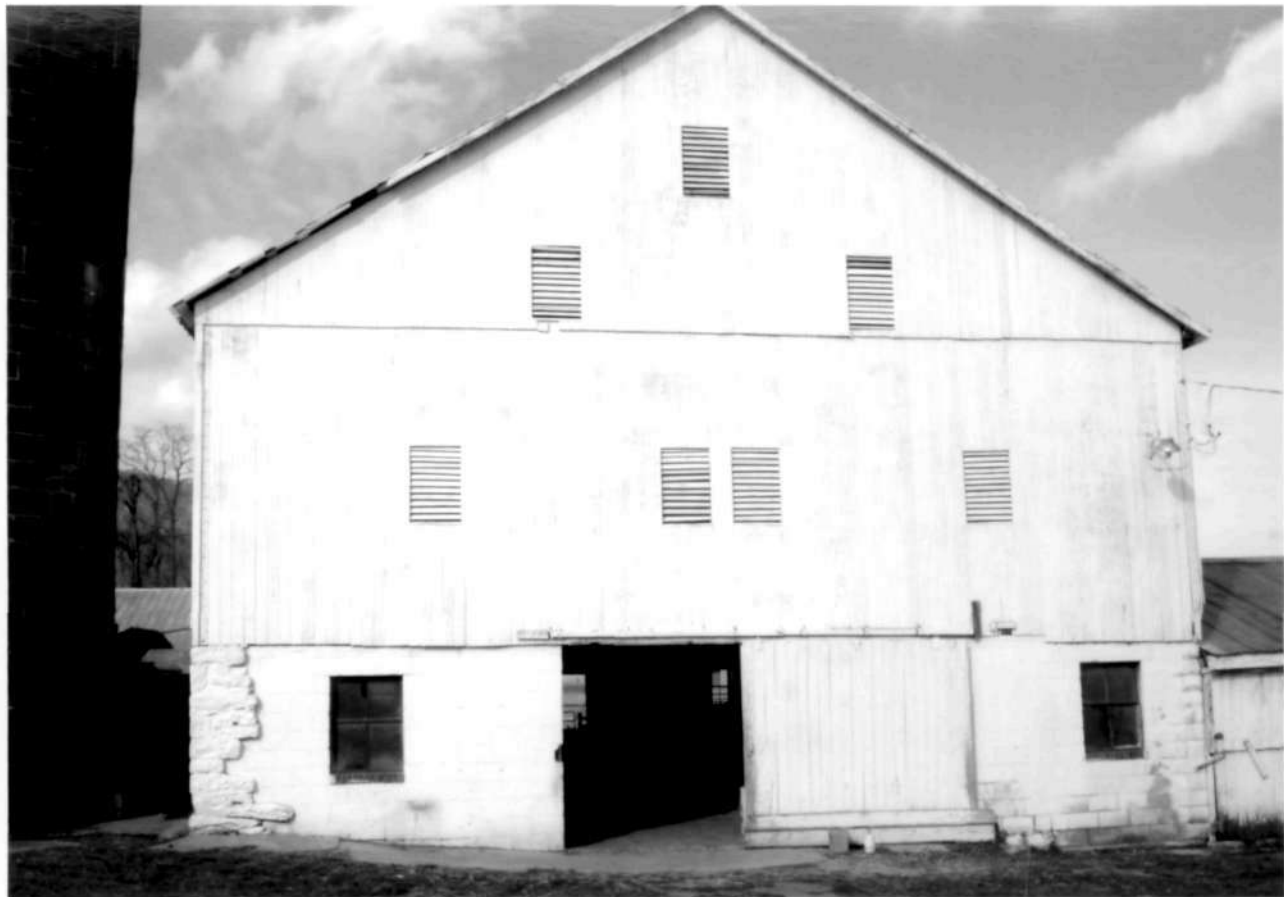
Two barns are associated with the Springfield Dairy Farm, both of which appear to date to the second quarter of the twentieth century. The slightly older of the two is a three-bay, gable-roof **bank barn (7)**, with attached **loafing shed (8)** and adjacent **terra cotta tile silo (9)**. The loafing shed appears roughly contemporary with the barn, while the silo, used to store animal fodder, is of a type commonly built in the 1920s and 1930s. The silo has a metal roof and retains its wooden hay hood. The barn is built on the site of an earlier bank barn and utilizes recycled timbers and stone from the foundation of the earlier structure. Narrow gauge, vertical siding covers the walls. Upper windows are fitted with louvered inserts, while 4-light, fixed-metal-sash windows illuminate the lower level.

The bank barn's form recalls traditional 2-level dairy barns of the 19th and early 20th century, but the lower level is built with concrete block and has a poured concrete floor suggesting it was constructed to conform to changing hygienic standards and health regulations related to the dairy industry. The two-level barn first appeared in New York about 1850 as farmers transitioned from traditional crop cultivation to dairy farming. Larger herds of milk cows required greater hay storage and resulted in the two-level dairy barn. The defining feature of this design is a centrally placed side entrance accessed on the upper level and a lower level that runs gable to gable. This biaxial configuration sets this type of bank barn apart from the more celebrated German-influenced bank barns. Two-level dairy barns of this type occur in greater concentrations in upstate New York, but examples can be found throughout the Mid-Atlantic states.⁶

Bank Barn
Camera Carc. North

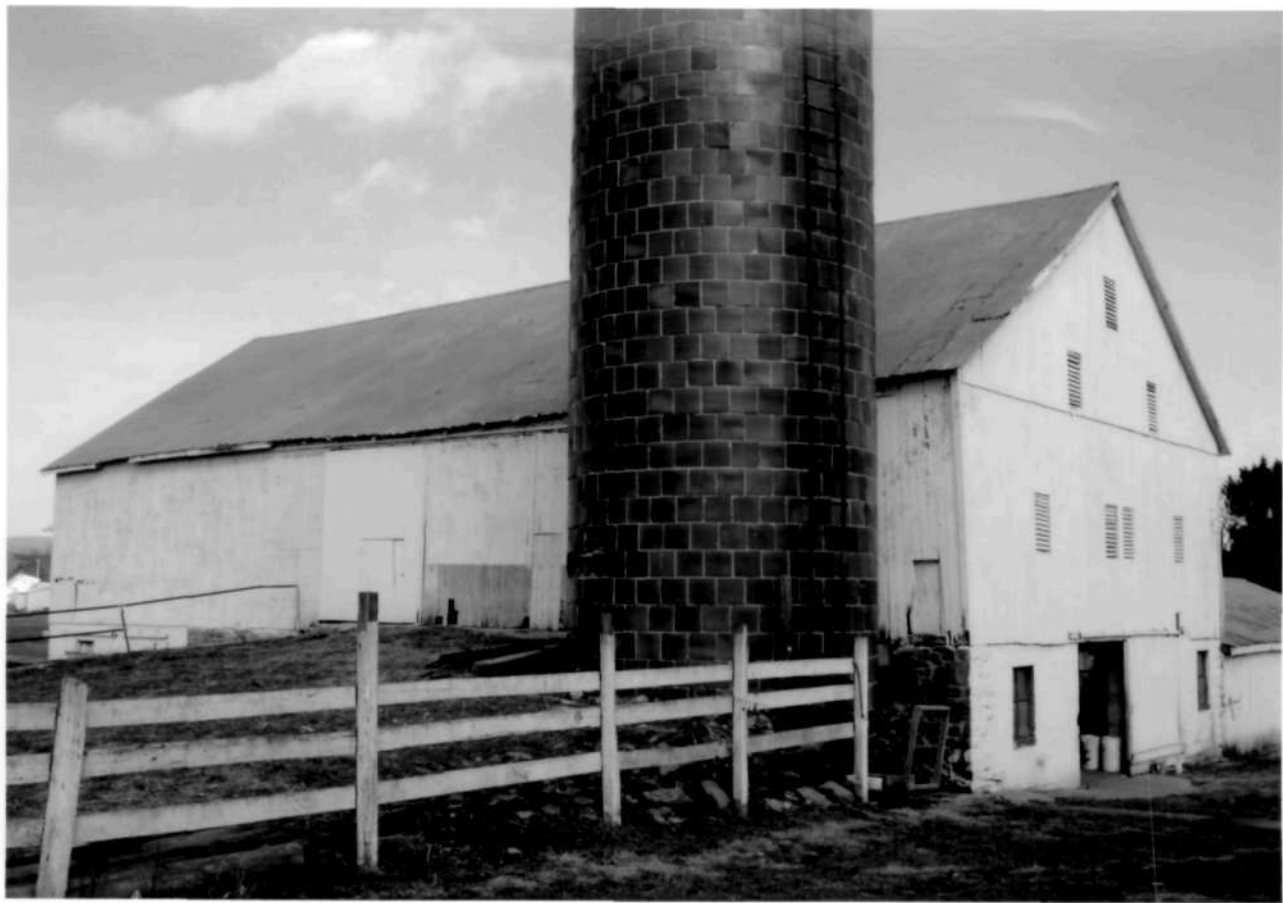
Bank Barn + Silo

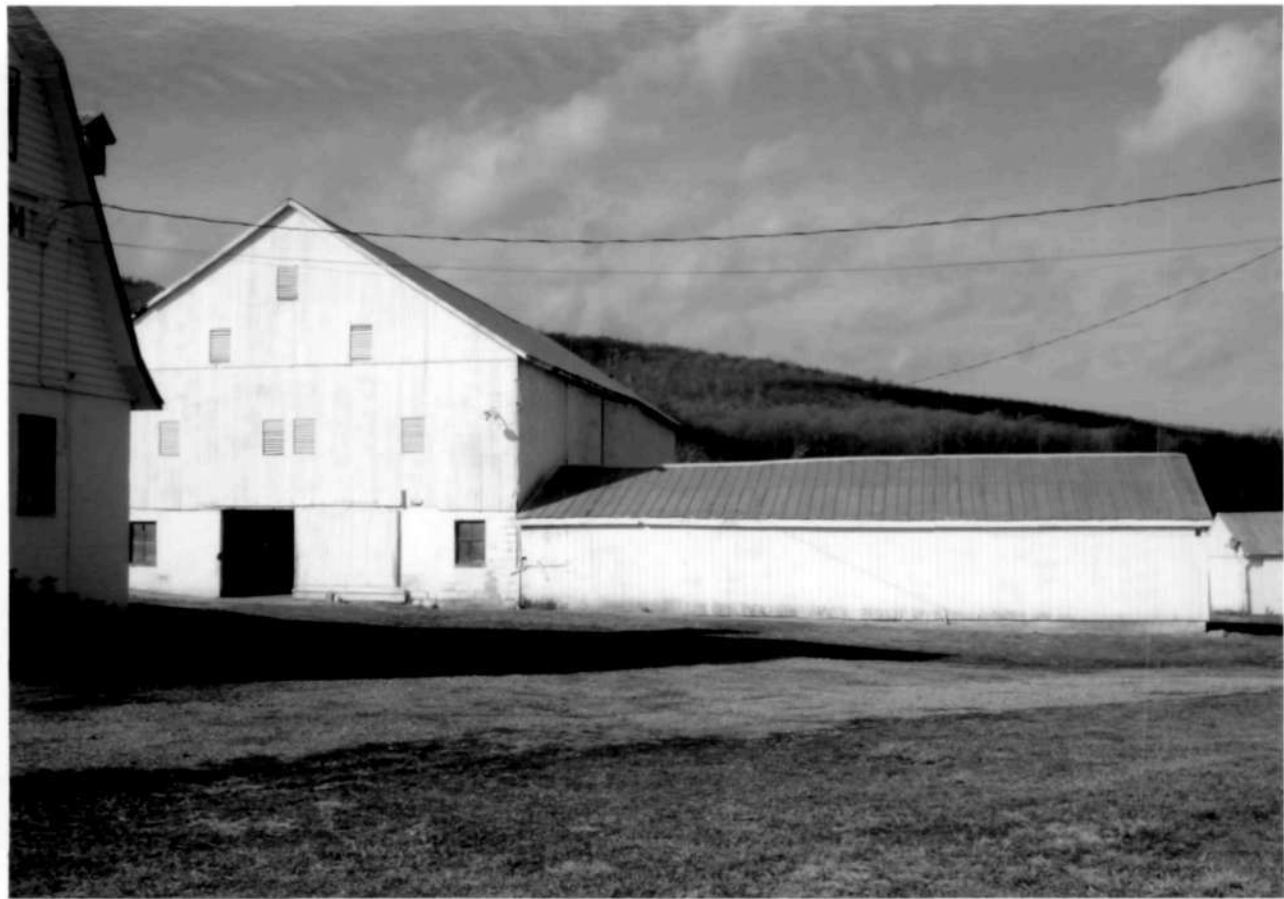
photo 14 of 21

BANK BARN + Loading Shed

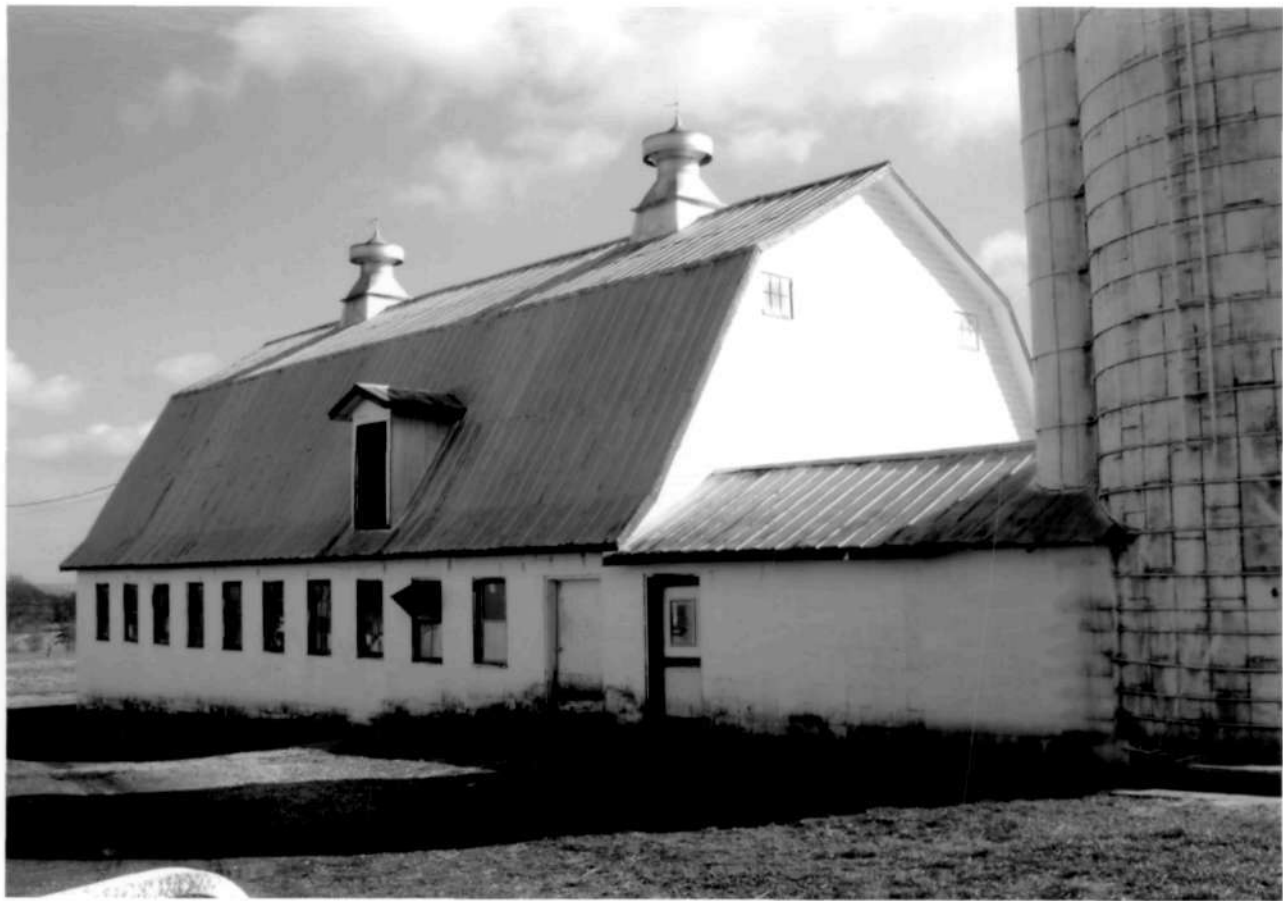
photo 18 of 1

The other barn is a classic transverse **dairy barn (10)**. Oral history and materials indicate it was constructed in the 1940s. While the bank barn's construction displays distinct vernacular influences, this transverse dairy barn follows designs widely promoted by state agricultural extension offices and publications aimed at farmers. It is a very popular form found throughout the nation's dairy farming areas. Gable-side entry, which is a definitive feature of transverse barns, produced a barn well suited to dairy farming. The form allowed easy access to all of the stabling areas. Hay was stored above stalls and could be

In this example, the first story is constructed of concrete block while the upper level has frame walls sheathed with German siding. Concrete block was chosen for its ease of cleaning. The metal-clad, gable roof has gently flared eaves. Two ventilators pierce the roof at the ridgeline. A hay door, styled as a dormer window, provides access to the upper level. The front (east) façade features a pair of wooden, board-and-brace, track doors that open into a center aisle. These doors are similar to the gable loft doors positioned above. "Springfield Dairy Farm" is painted under the loft opening. With respect to additional fenestration, ten, six-over-six, metal-sash windows and a pedestrian entrance punctuated the side walls.

DAIRY BARN

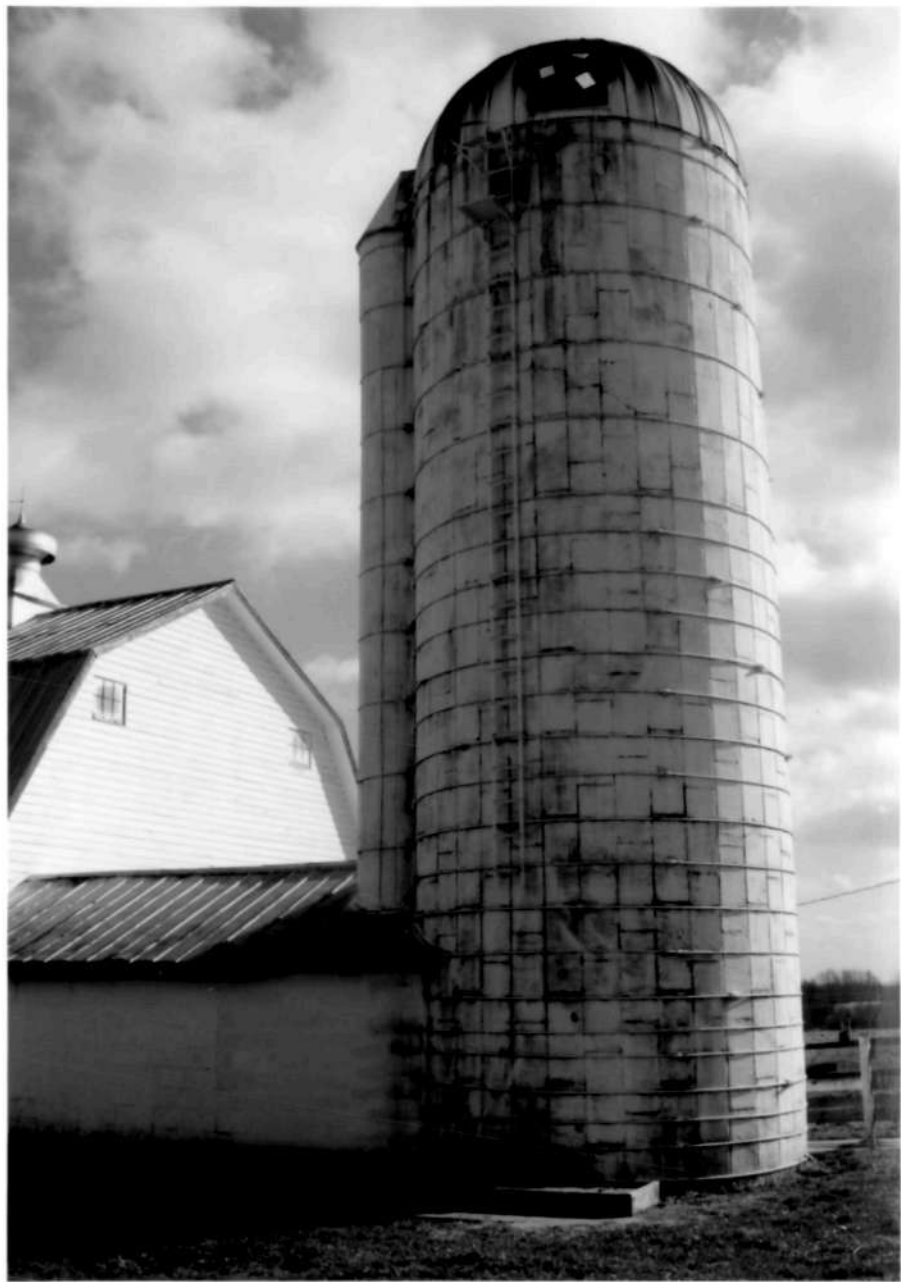
photo 10 of 21

A **concrete silo (11)** with securing turnbuckles is situated behind (west) the dairy barn. A narrow concrete hyphen connects the silo to the barn. Lanier and Herman informs us that poured concrete and concrete block silos appeared contemporaneously with terra cotta examples, but concrete construction remained popular for a longer period of time. Silos, among the most conspicuous structures on a farmstead, are a relatively recent phenomenon. Silos first appeared on the landscape in the later part of the 19th century, becoming a common feature in the 20th century. Used to grain or green fodder (ensilage) silos allowed farmers to store more feed and therefore maintain larger numbers of cattle. Silos are particularly common on dairy farms because cows fed on ensilage produce milk throughout the winter.⁸

Silo

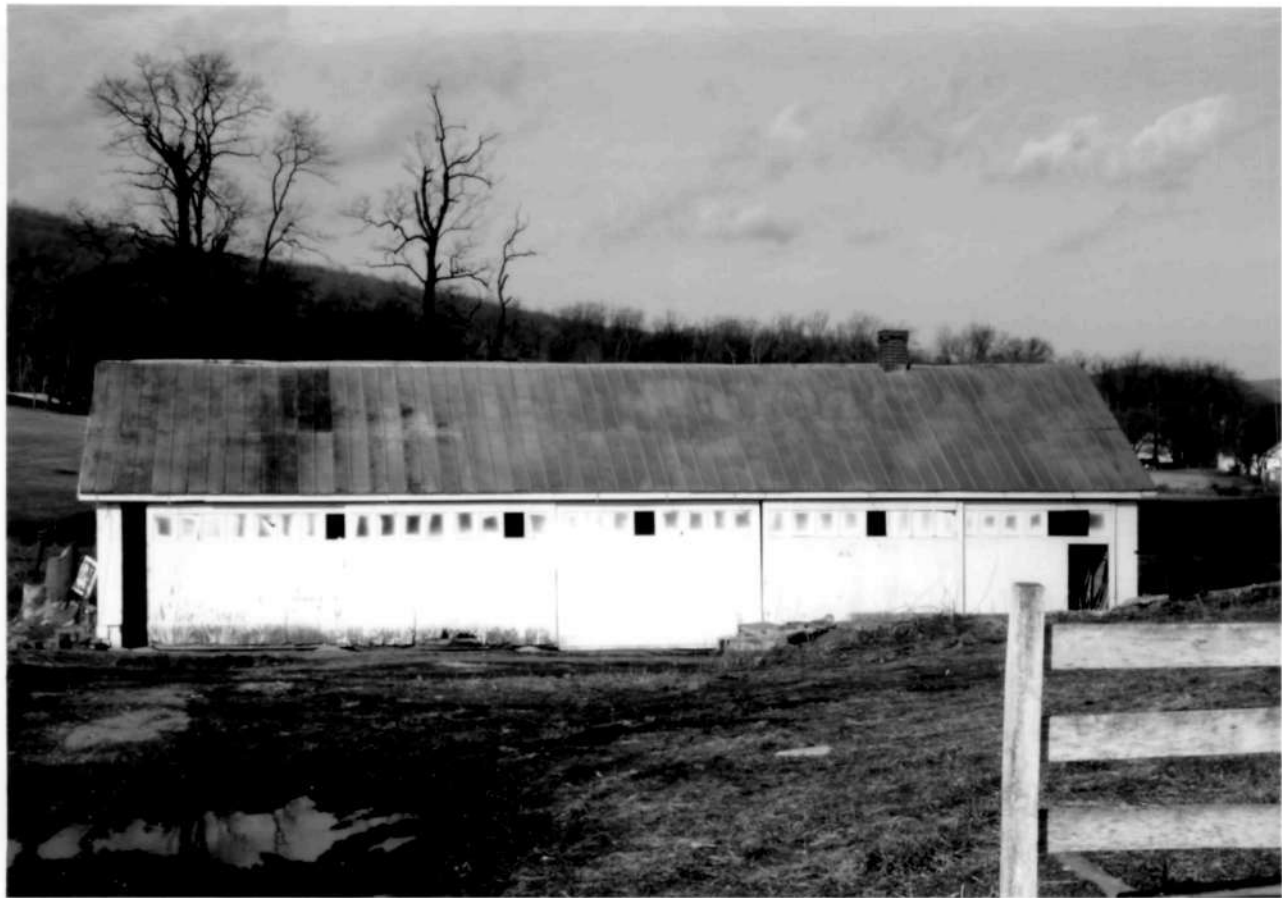
The farm's remaining building is situated north and west of the bank barn. The **machine shop (13)** is constructed of concrete block, and measures roughly 50' x 20'. The floor is poured concrete. The gable roof is covered with standing-seam metal and pierced at the ridge line, near the east end, by a small, corbelled chimney. The south façade features five bays, each fitted with a sliding garage door. Fenestration consists of a band of windows in the upper section of the garage doors, two 6/6 windows in the end walls, and a fixed-sash, six-light window in the gable. The machine shop was used to repair and service vehicles and equipment. It is a common building form on modern farms. This example dates to 1941. The construction date is inscribed on the building's interior. It is in fair condition.

machine shop

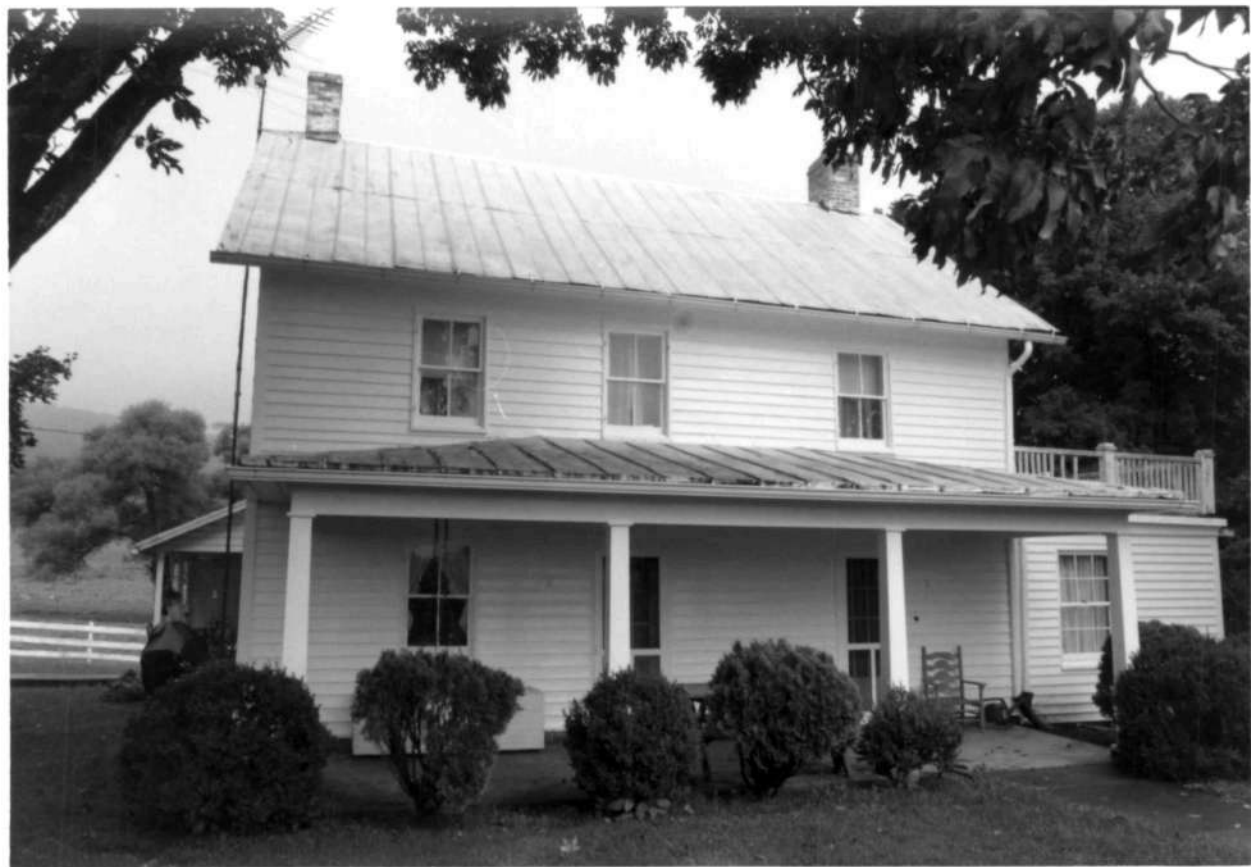
1/6

South elevation

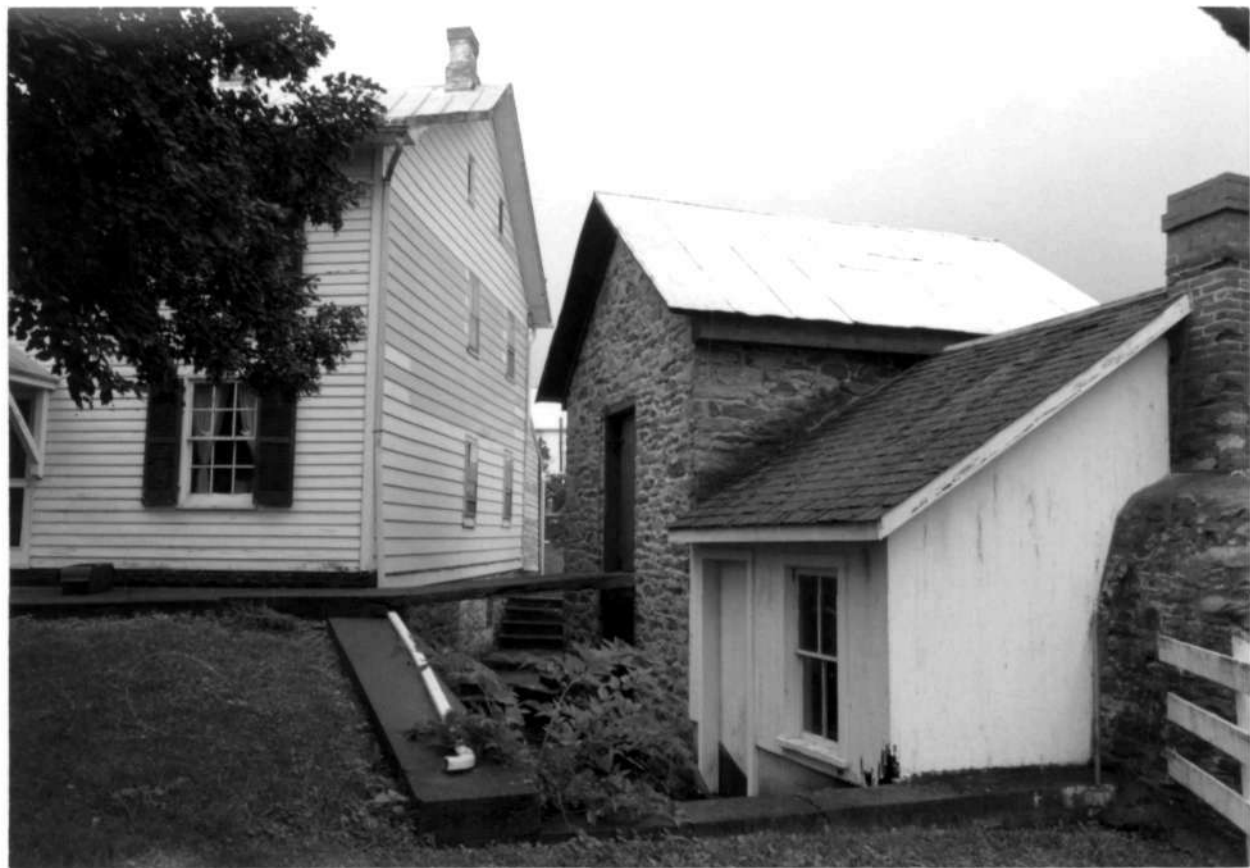
2/6

Springhouse and Summer Kitchen, view from east

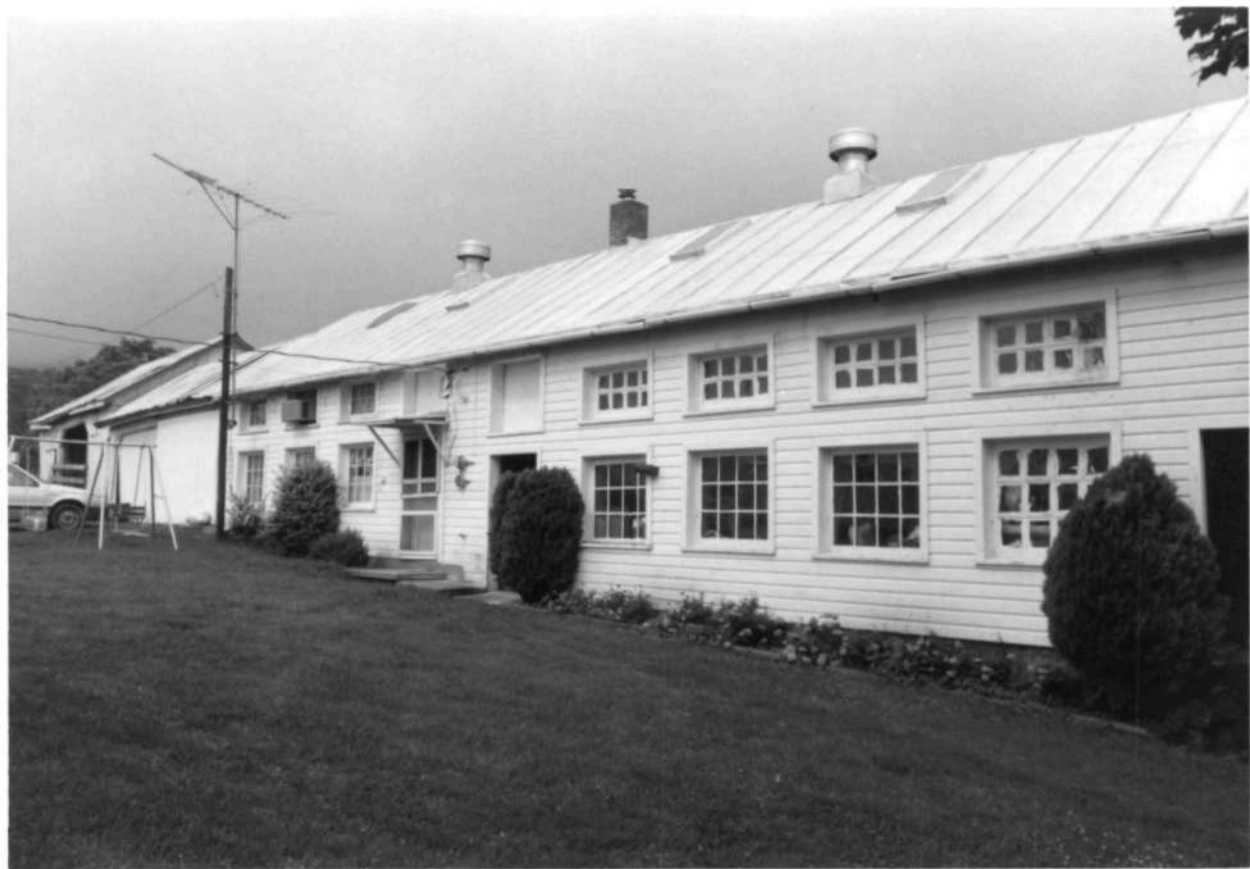
3/6

Chicken house and wagon sheds, view from
Southeast

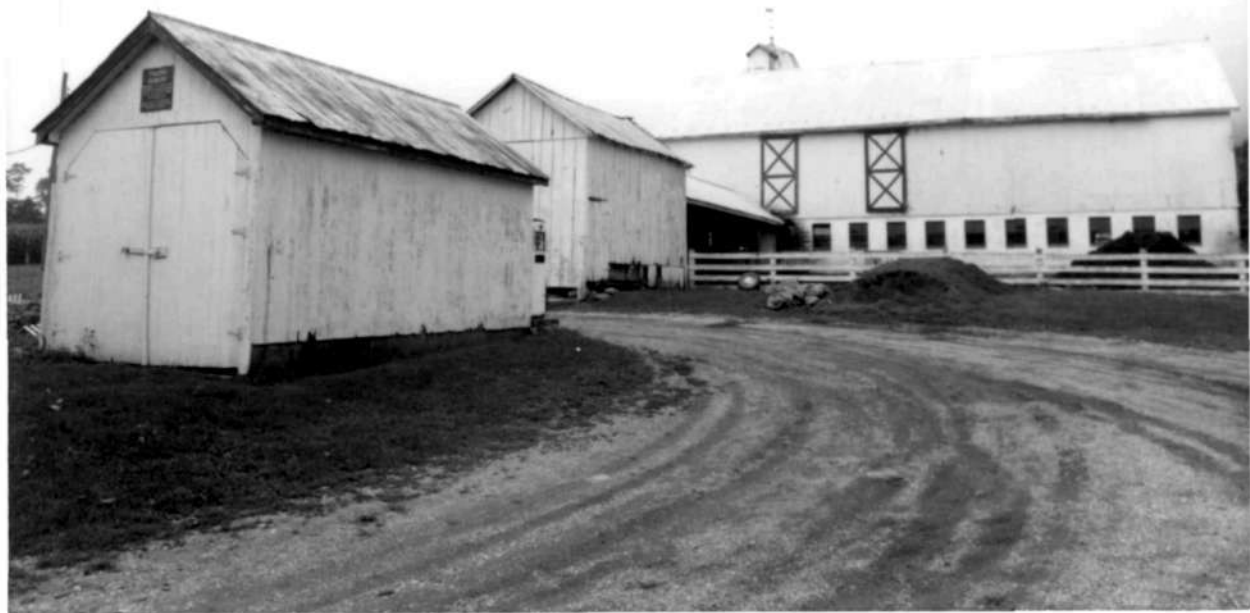
4/6

View west toward garage, hog barn, and
dairy barn

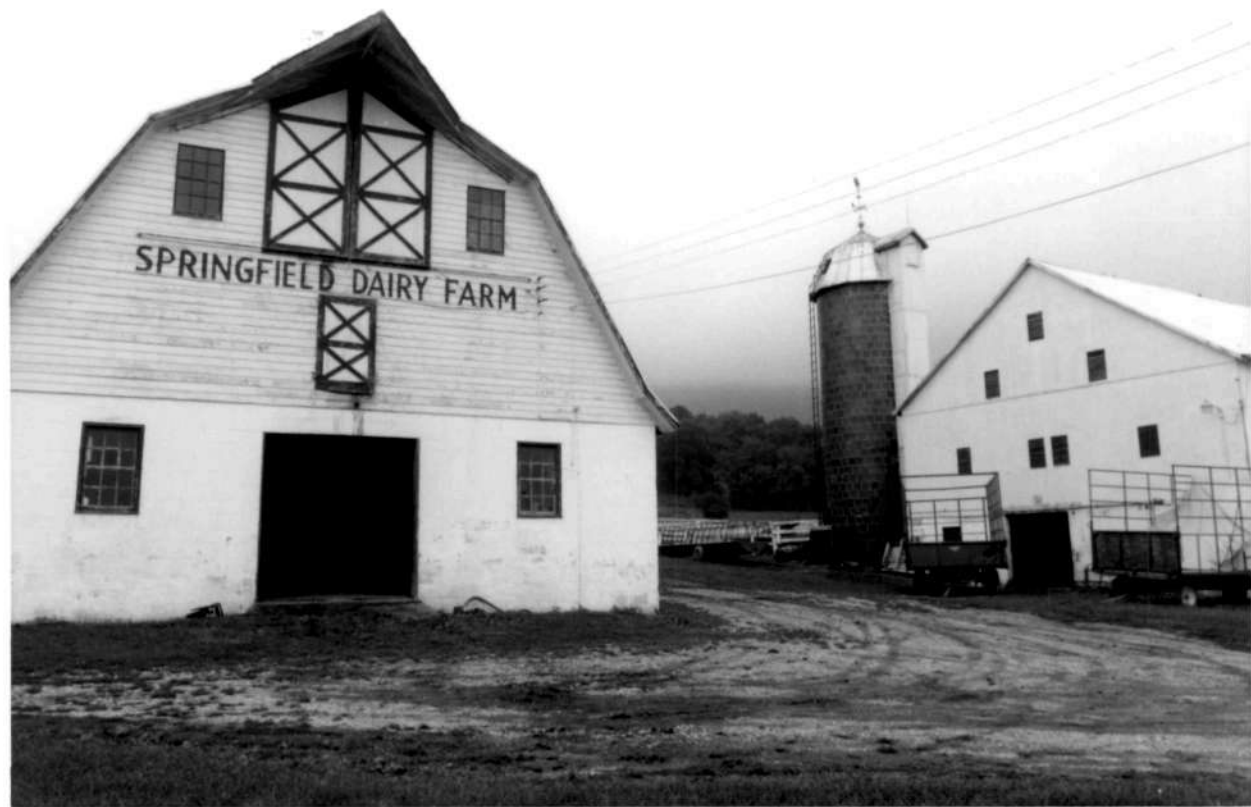
5/6

Dairy barns and terra cotta silo, view from
east
